**ANALYTICAL AND FIELD STUDIES OF
SAFETY ON EGYPTIAN HIGHWAYS**

KHALED ZAKY HUSSIEN SALEM

MASTER OF SCIENCE

**Shoubra faculty of engineering, Benha University
Egypt
June 2012**

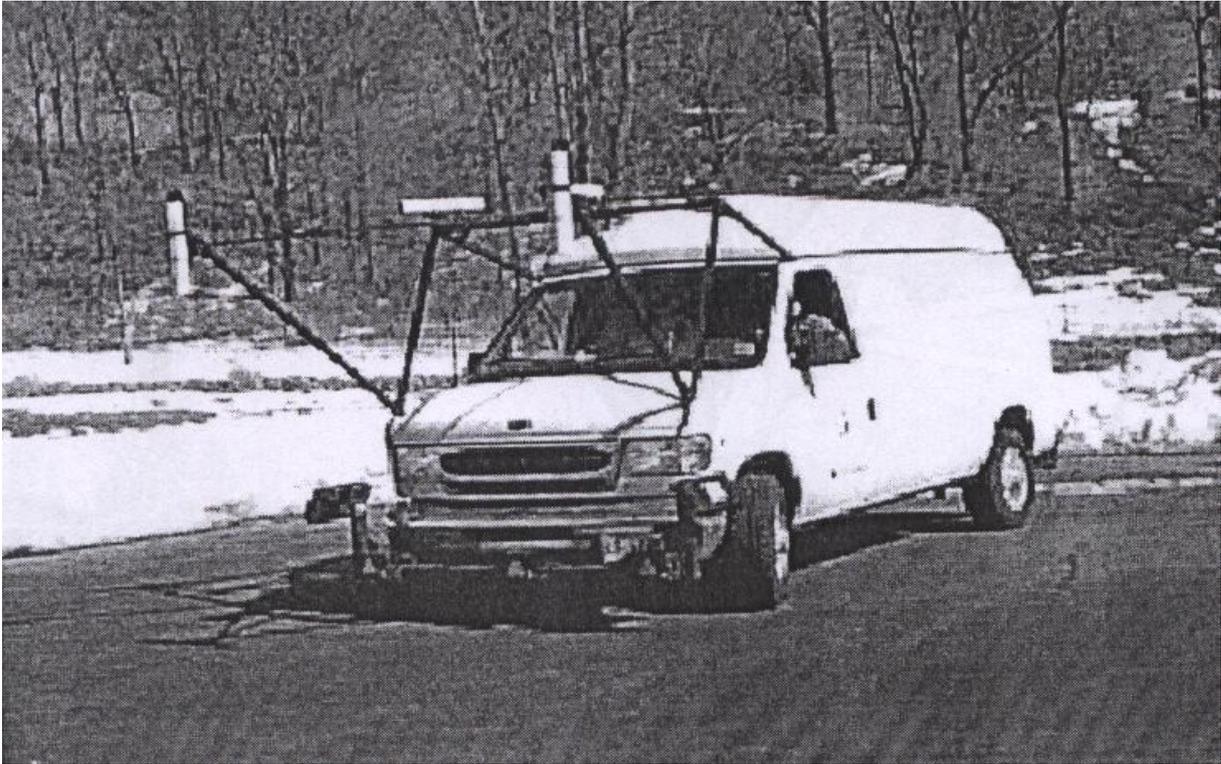
Figure (2-6): MN/DOT's pathway service, Inc. video inspection vehicle (VIV)

They take a measurement approximately every 1/8 -inch as the van travels down the pavement at highway speed. The cameras are used to capture the pavement distress (cracking, patching ... etc) and help assess the overall condition of the pavement.

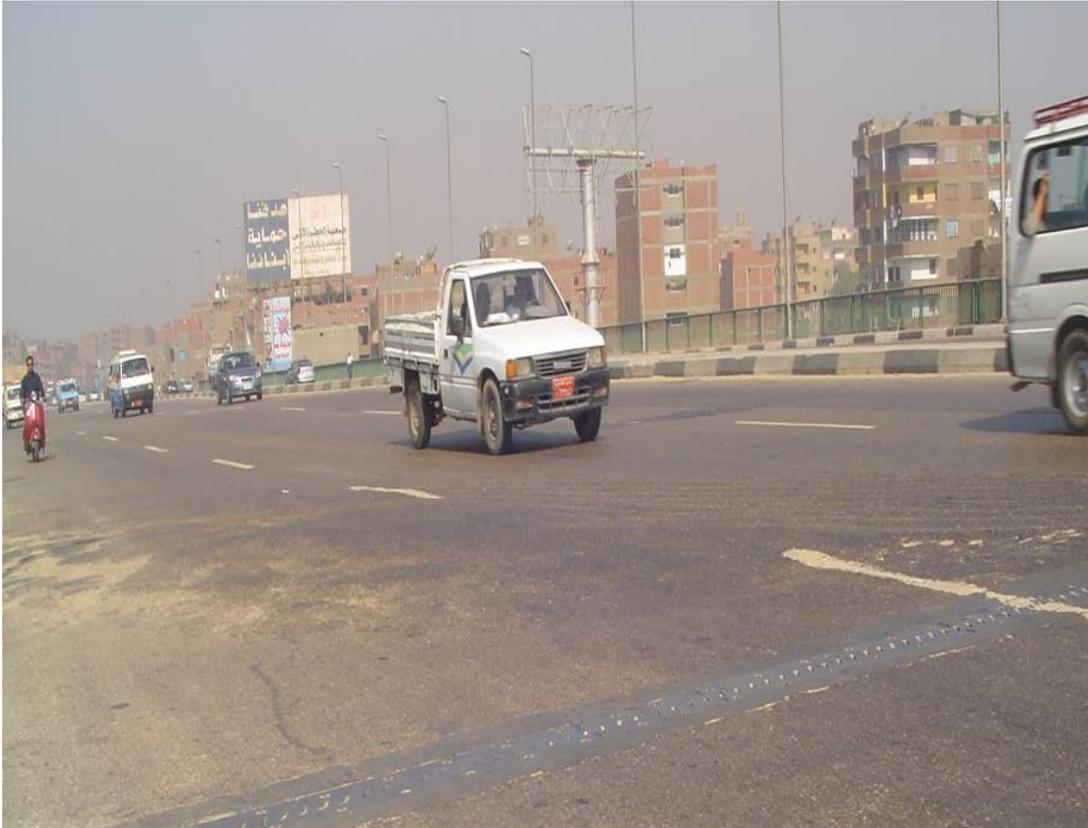
Figure (3-2): Shoving, outer carriageway, (km 7.1).

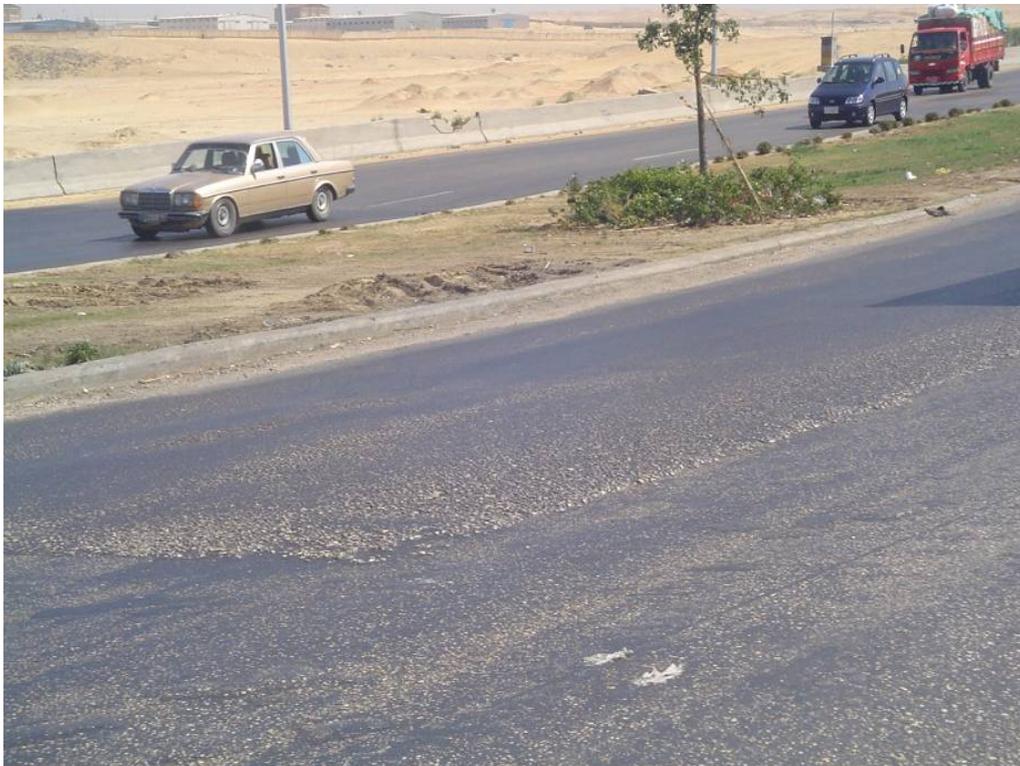
Figure (3-3): Depression and corrugation, outer carriageway, (km 23).

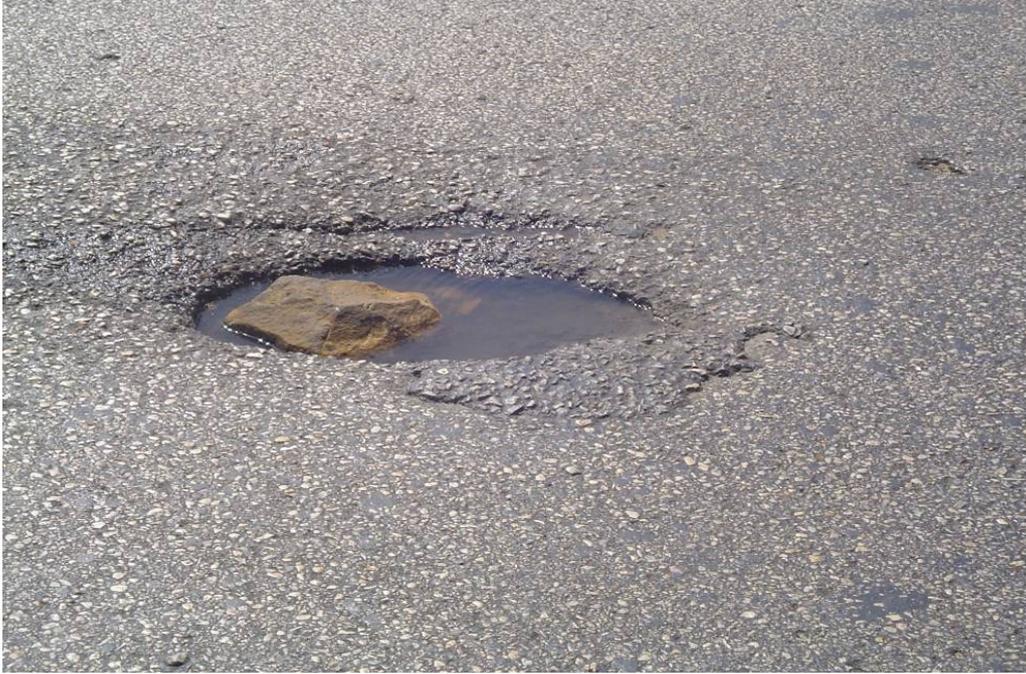
Figure (3-4): Pothole, outer carriageway, (km 23.5).

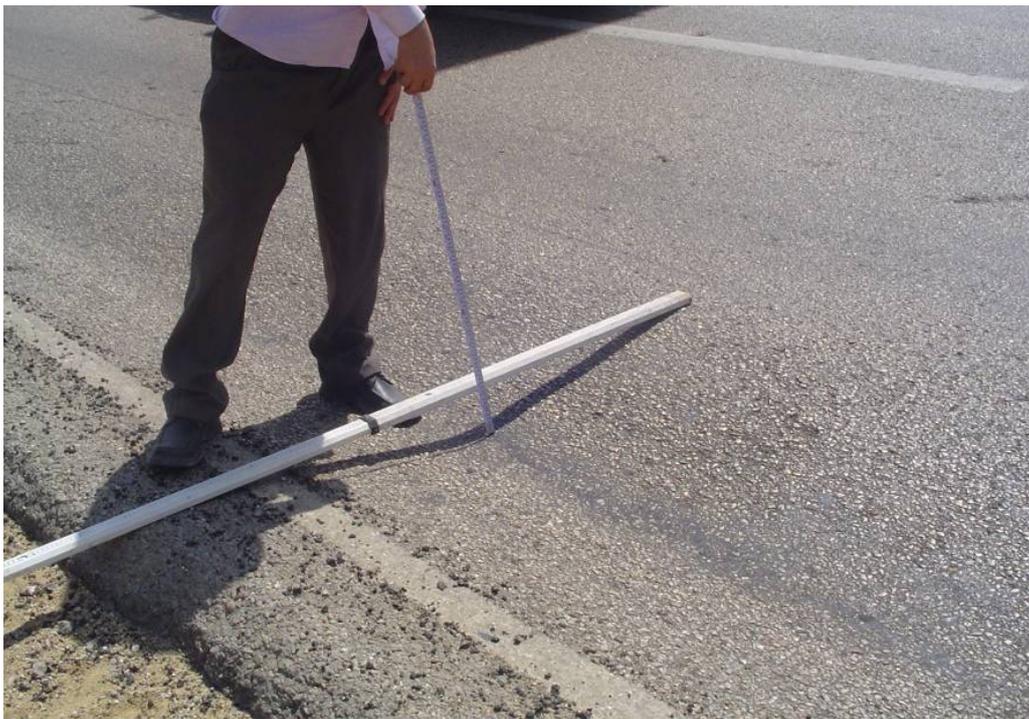
Figure (3-5): Rutting, outer carriageway, (km 41.9).

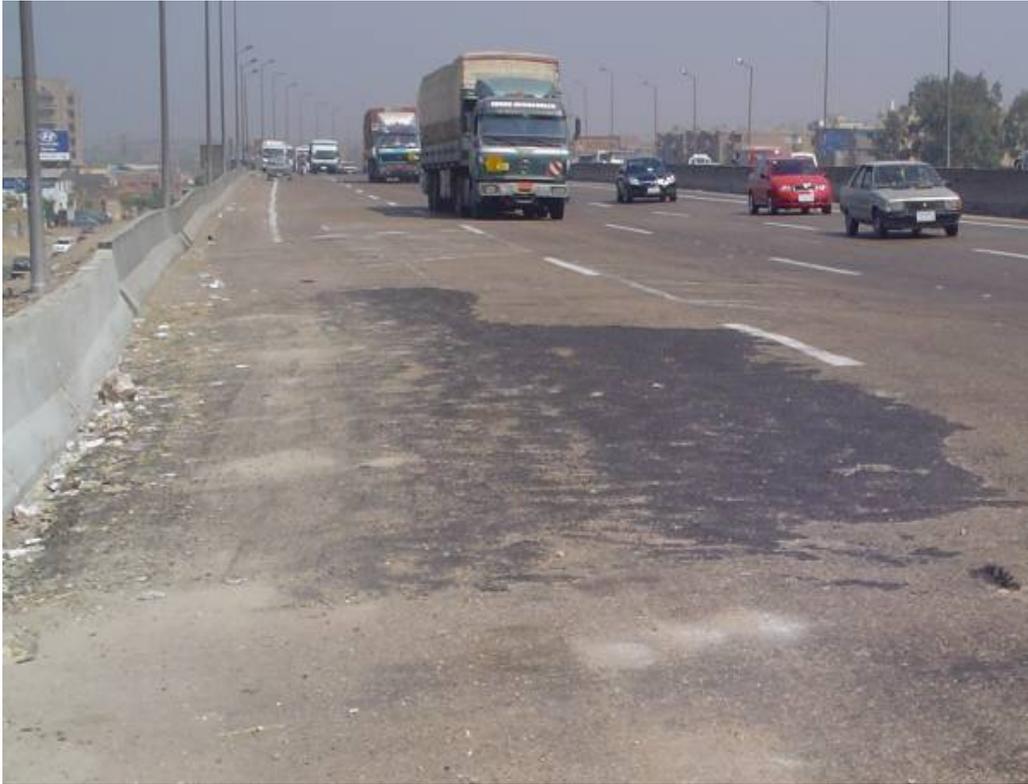
Figure (3-6): Bleeding, inner carriageway, (km 49.4).

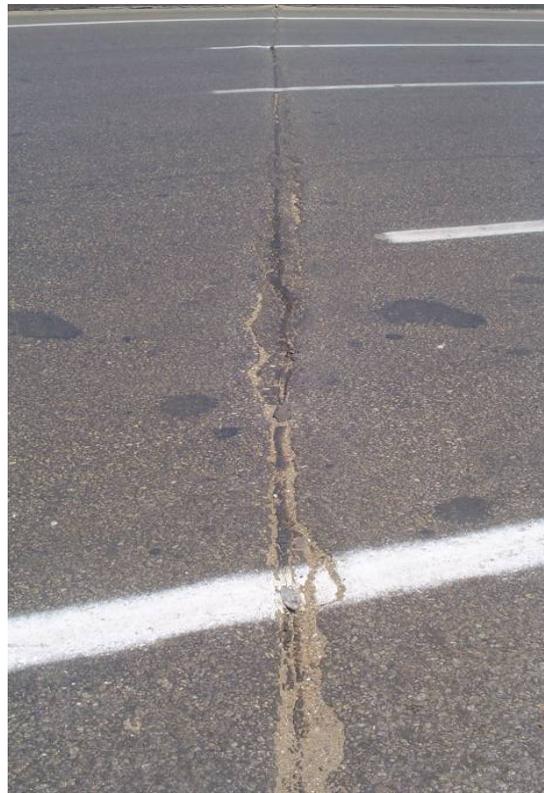
Figure (3-7): Transverse crack, inner carriageway, (km 69.9).

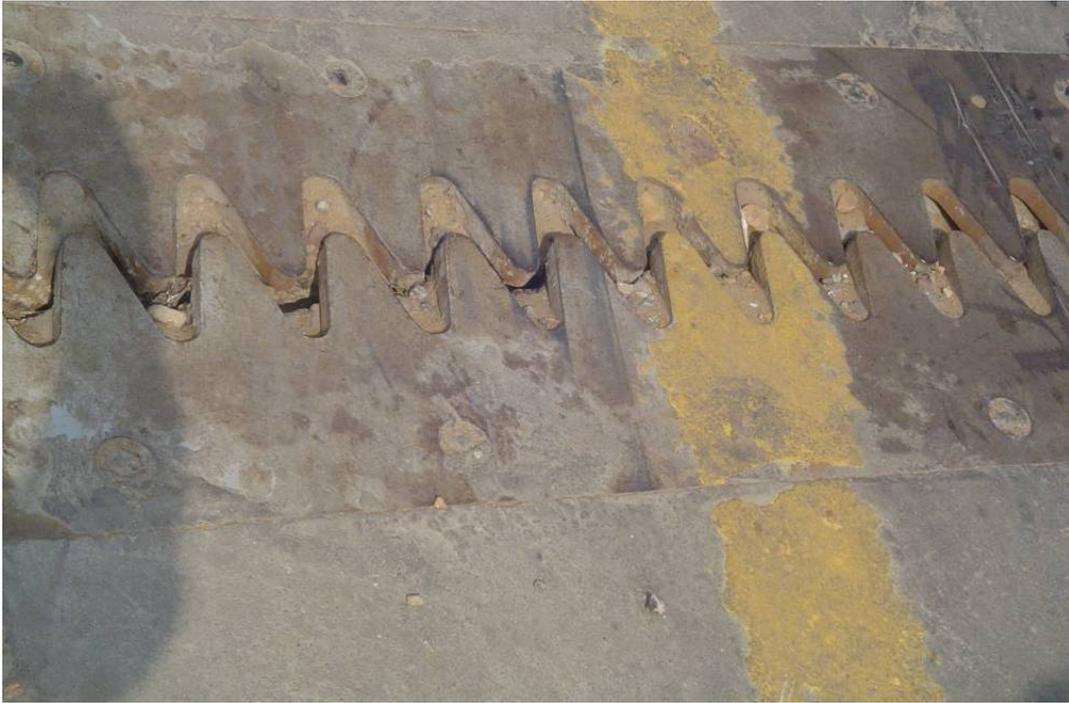
Figure (3-8): Bridge finger joint.

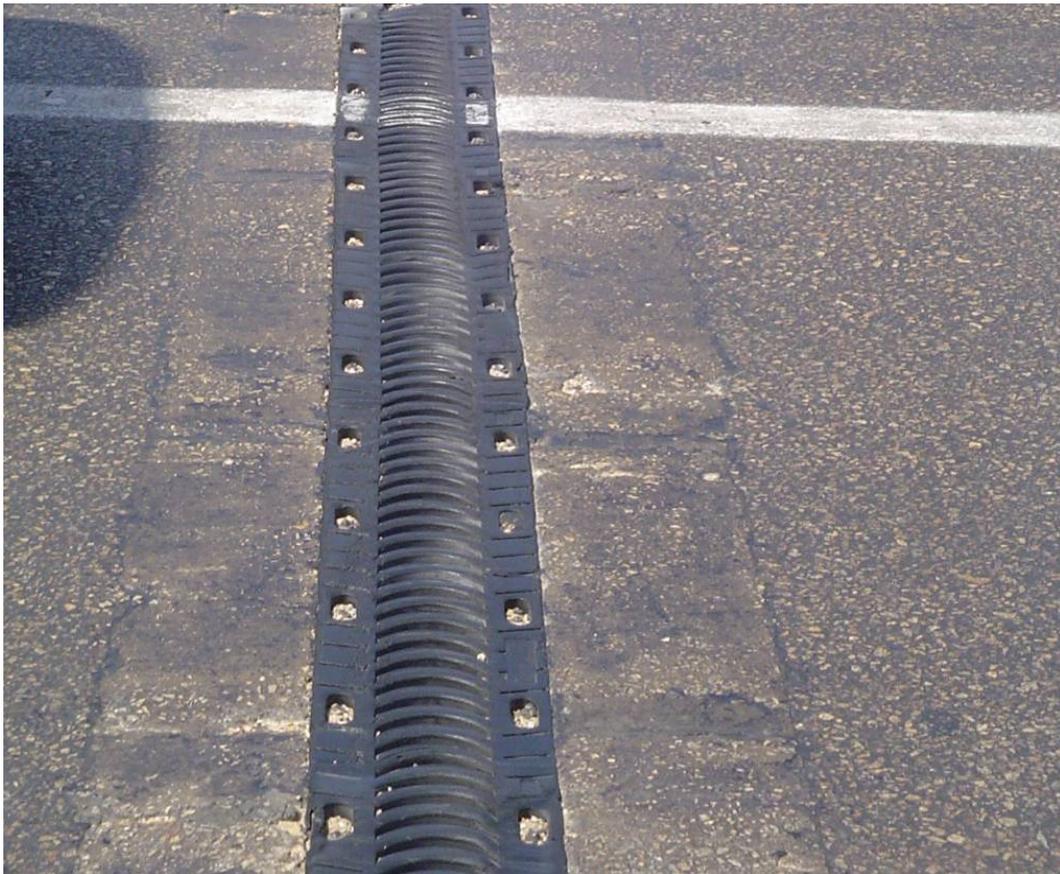
Figure (3-9) Closed 'sealed' bridge joint.

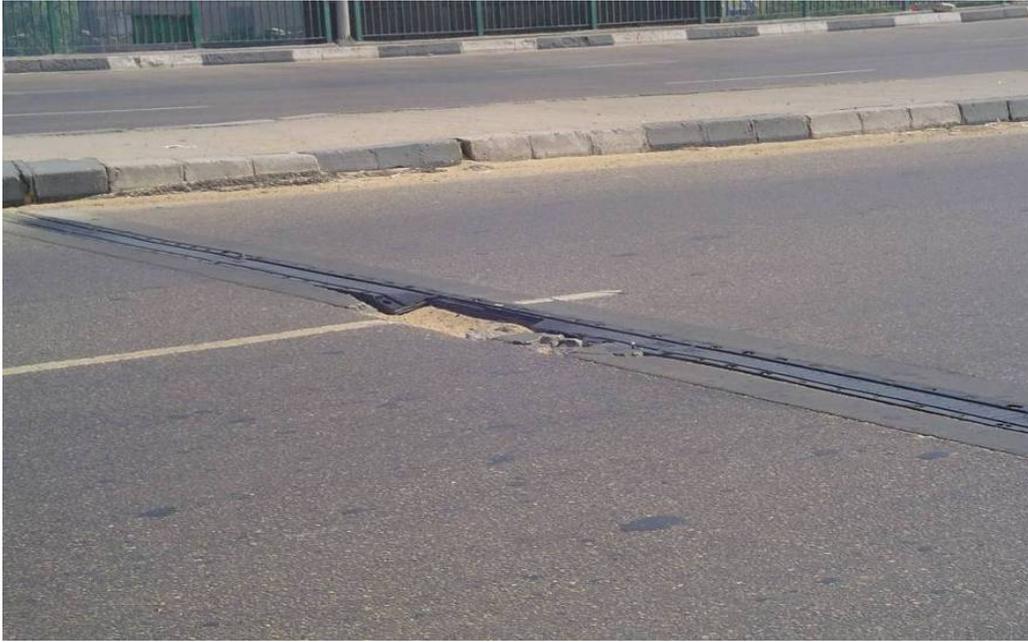
Figure (3-10): Damaged bridge joint, outer carriageway, (km 7.2).

1. Severe truck loading of bridges than was envisaging during their design due to increased traffic and higher axle loads.
2. Lack of quality during construction of joints.
3. Other causes include inadequate fatigue design of joints.
4. Fabrication defects.

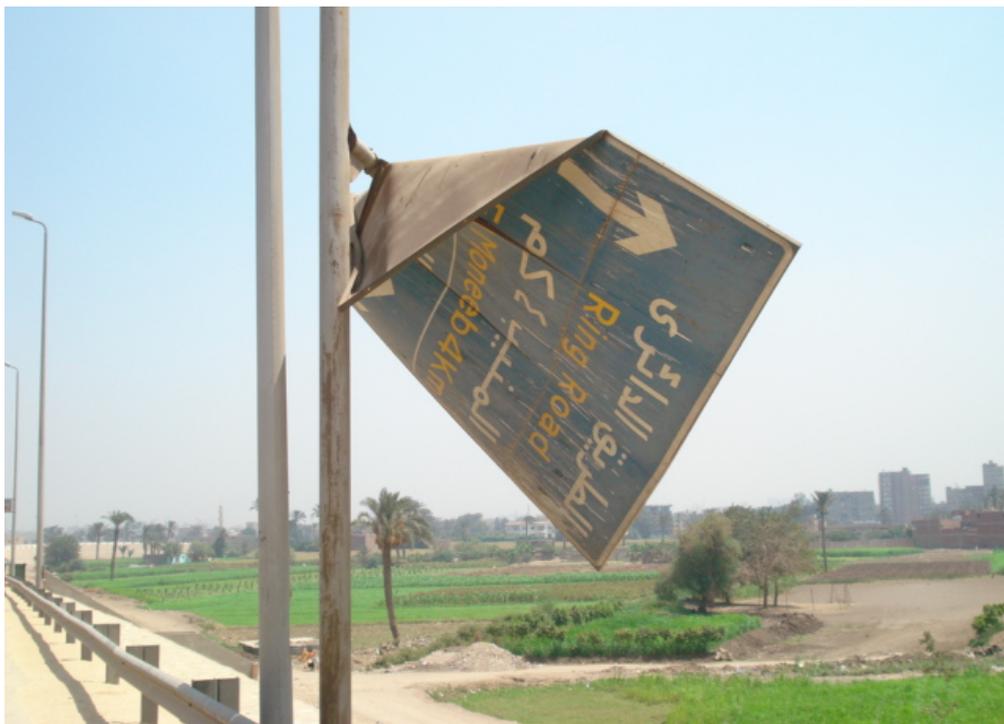
Figure (3-12): Damaged traffic sign, outer carriageway, (km 2.0).

There is a total of 580 m of damaged concrete New Jersey barriers, of which 165 m are located in the Ring Road median. There is a total of 145 m of damaged metal W-beam guard rails. There is a total of 80 m of damaged bridge rail, mostly located at km 90. Examples of the damaged traffic safety barriers and signs are included in Figures (3-12) to Figure (3-16).

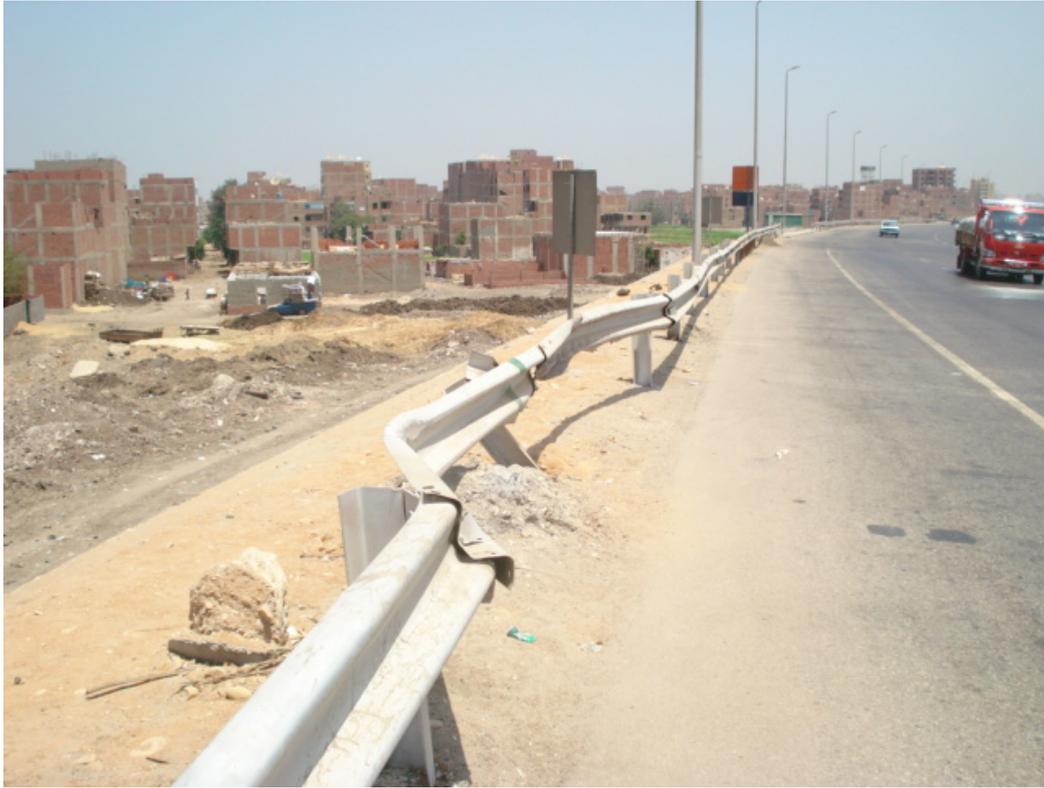
Figure (3-13): Damaged W-beam traffic guardrail, outer carriageway, (km 88.5).

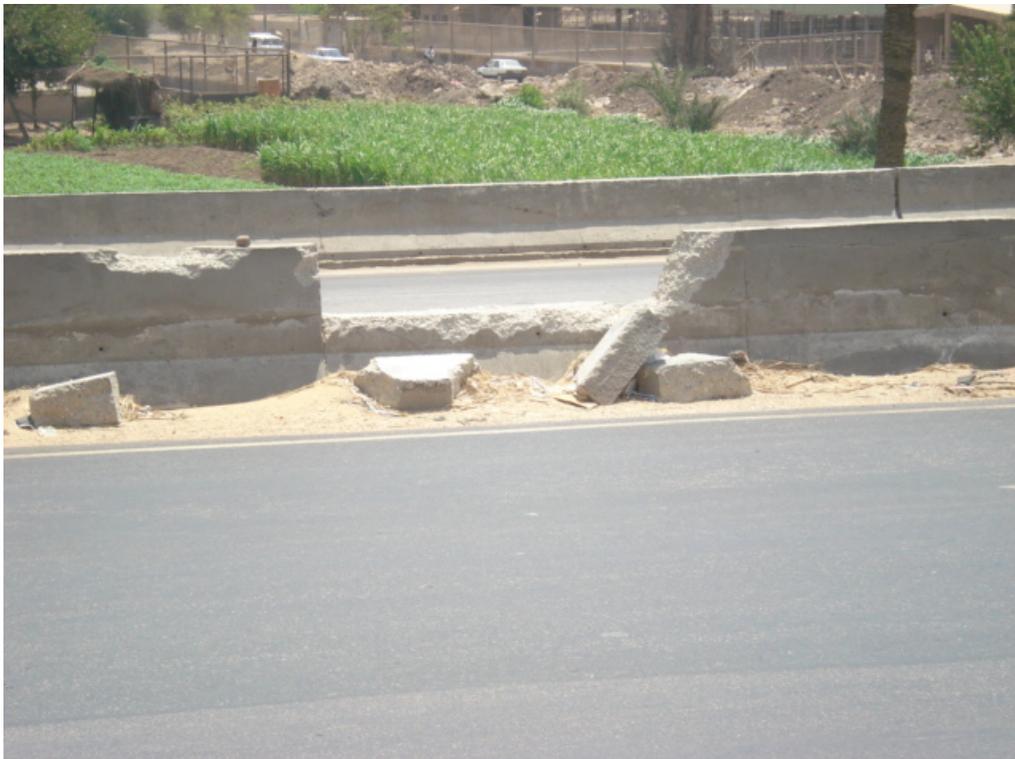
Figure (3-14): Damaged median concrete barrier, (km 88.5).

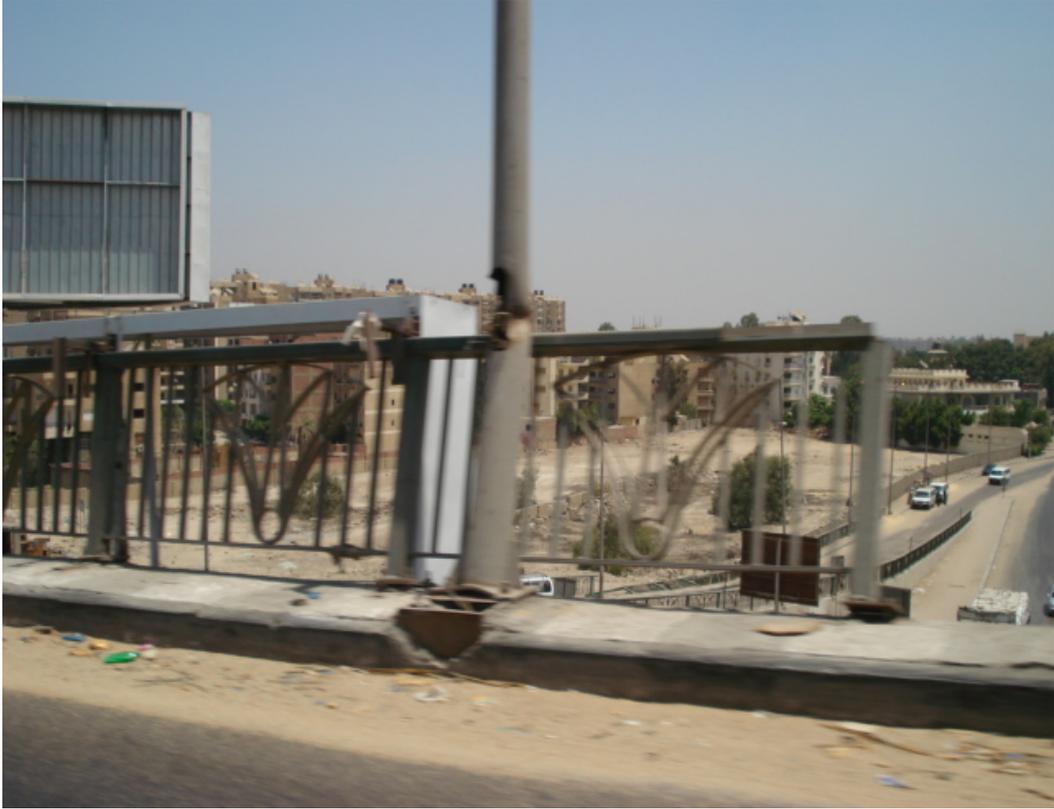
Figure (3-15): Damaged bridge rail, inner carriageway, (km 90.9).

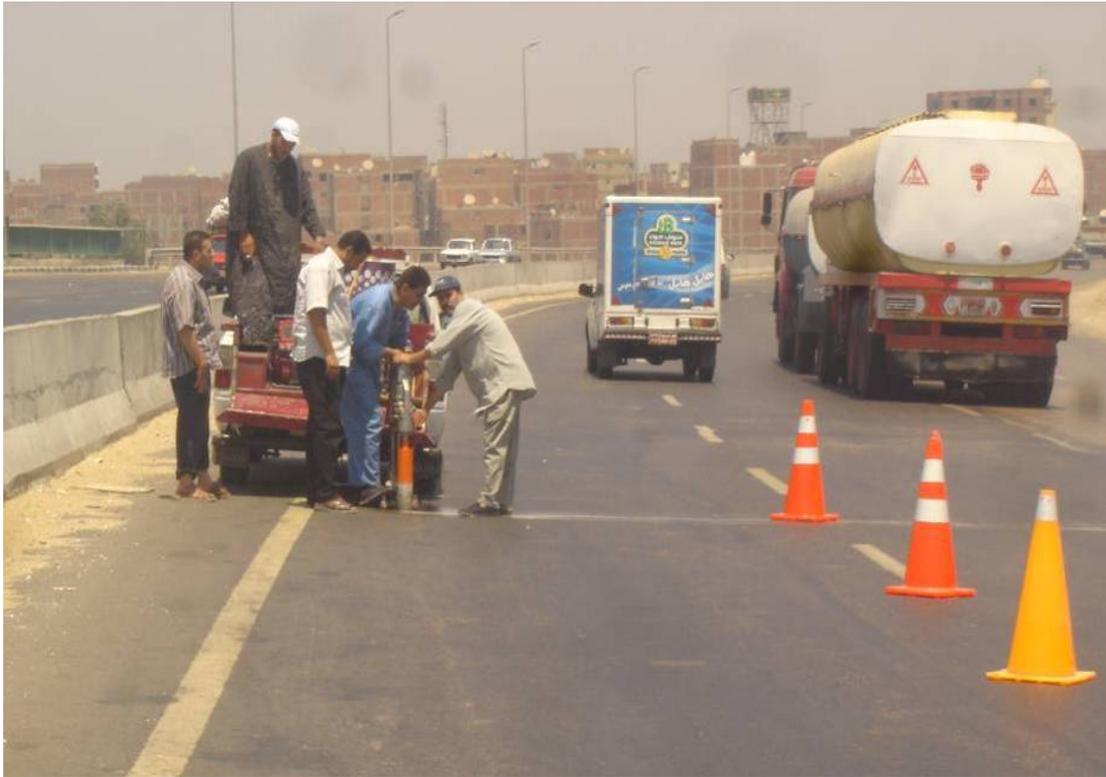
Figure (4-3): Sample of core extraction.

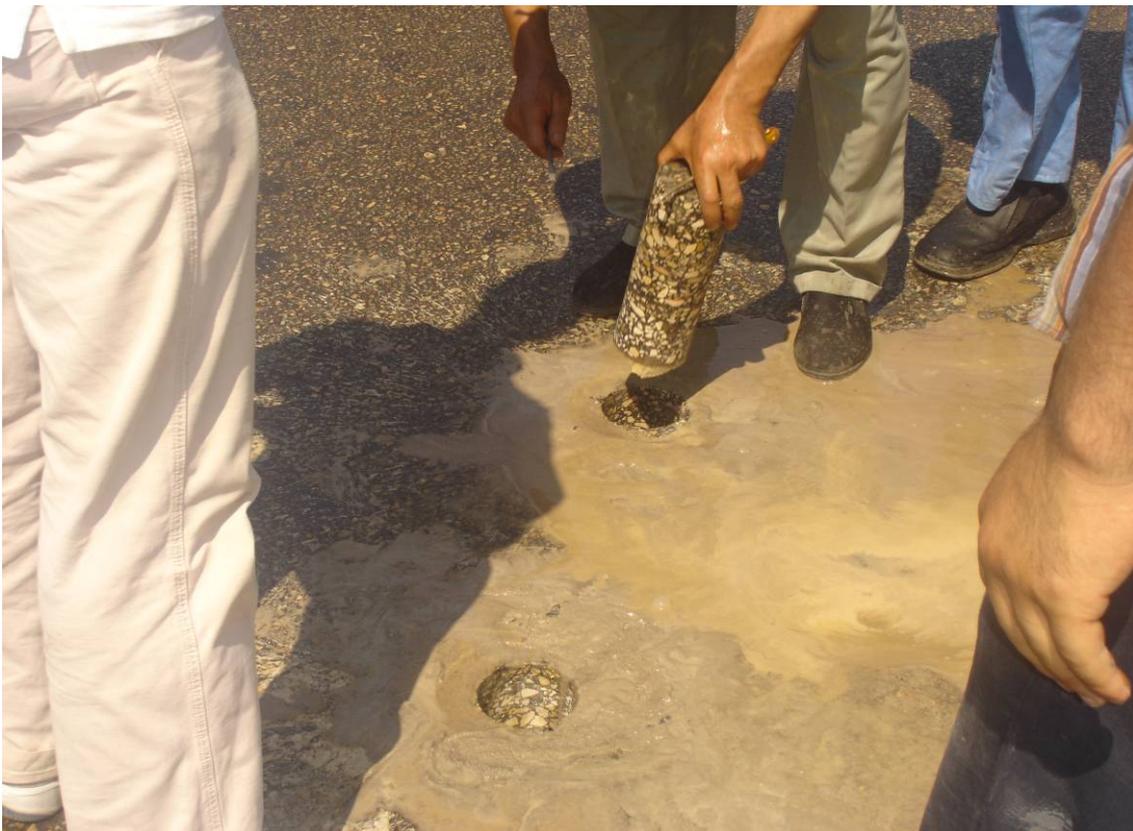
Figure (4-4): Sample of core extraction.

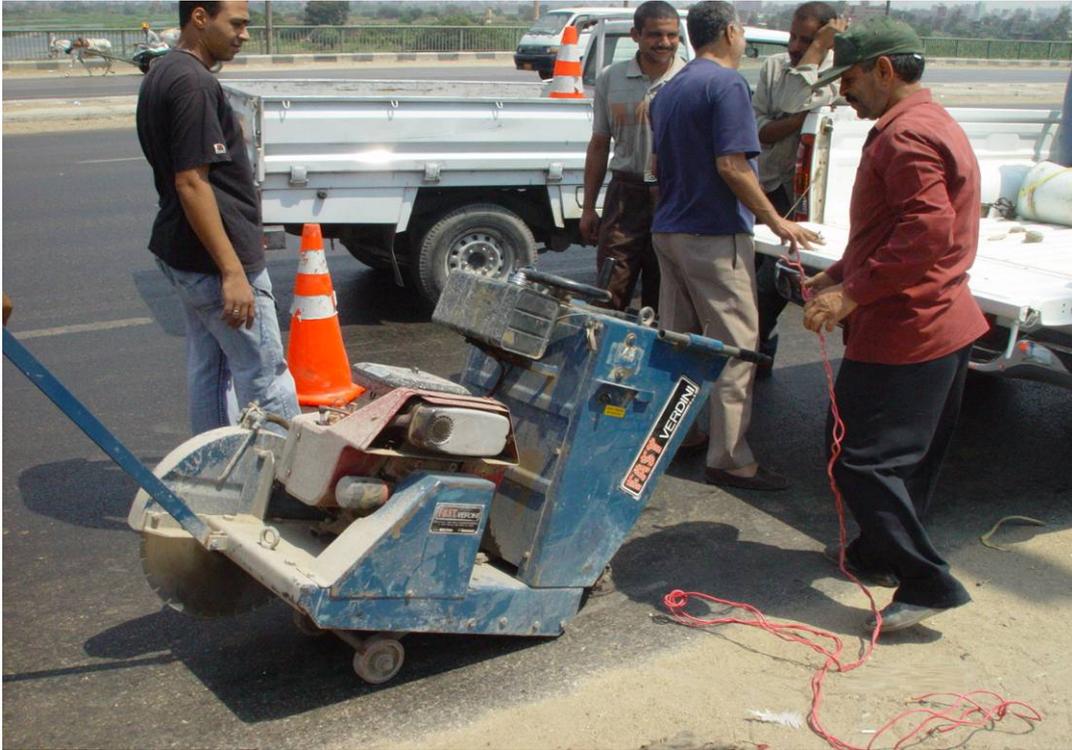
Figure(4-6): Sample of open pit extraction.

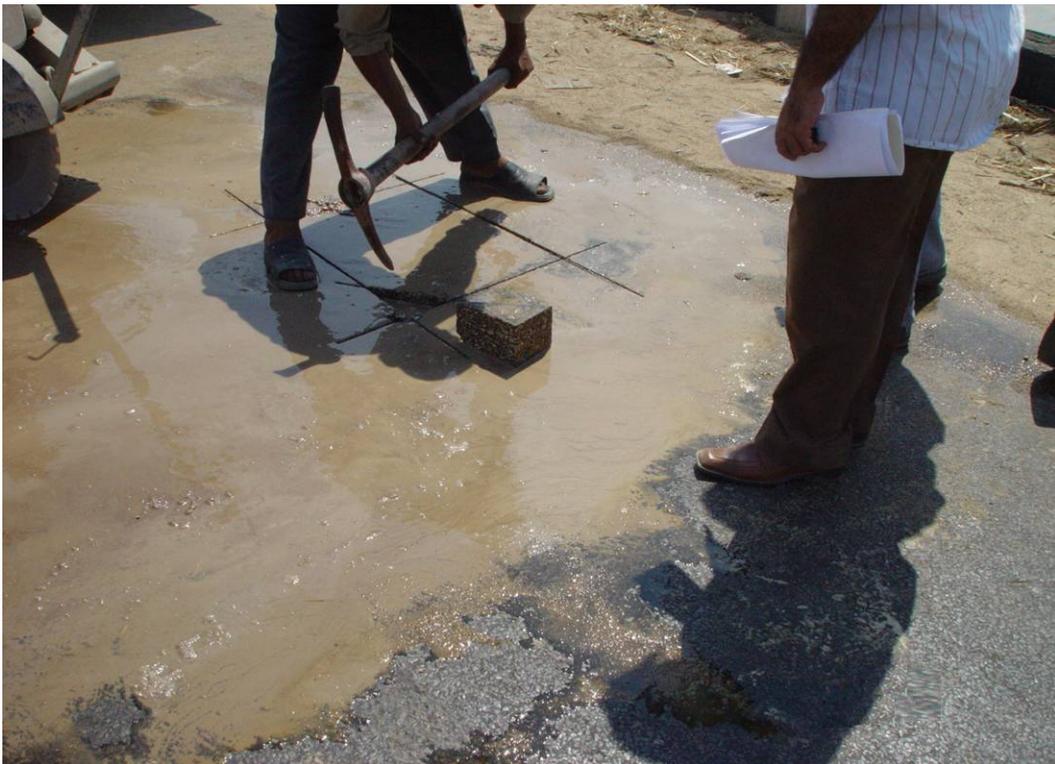
Figure (4-7): Sample of open pit extraction.

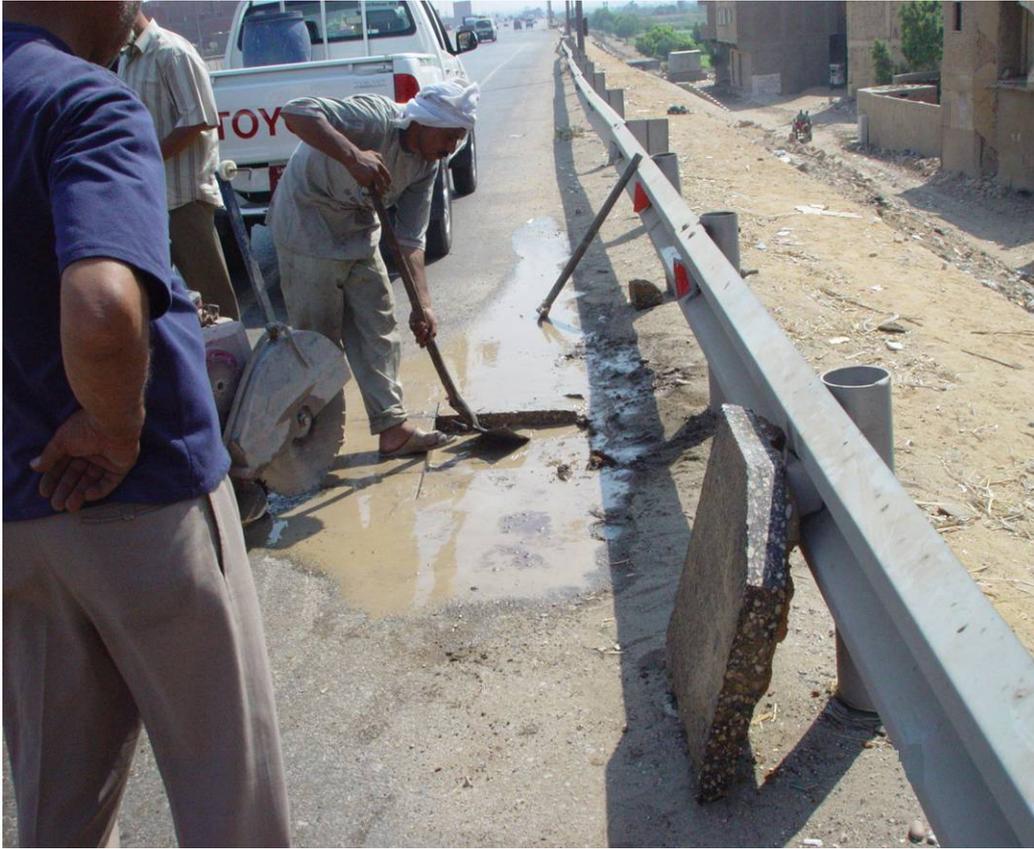
Figure (4-8): Sample of open pit extraction.

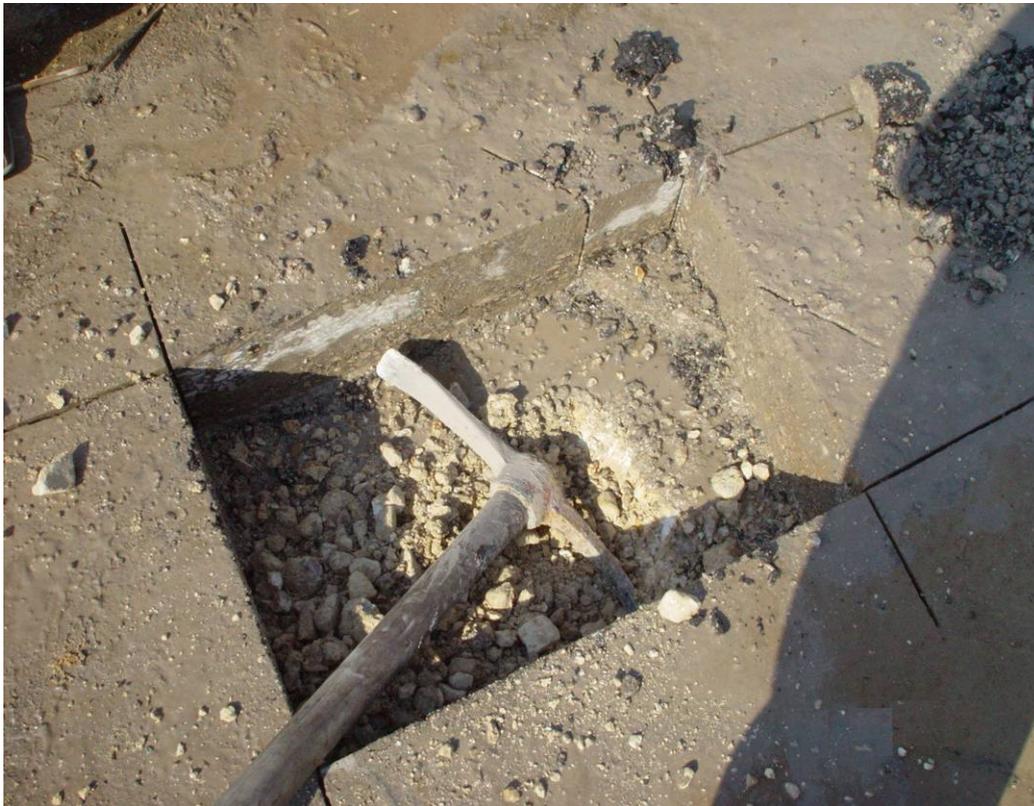
Figure (4-9): Sample of open pit extraction.
